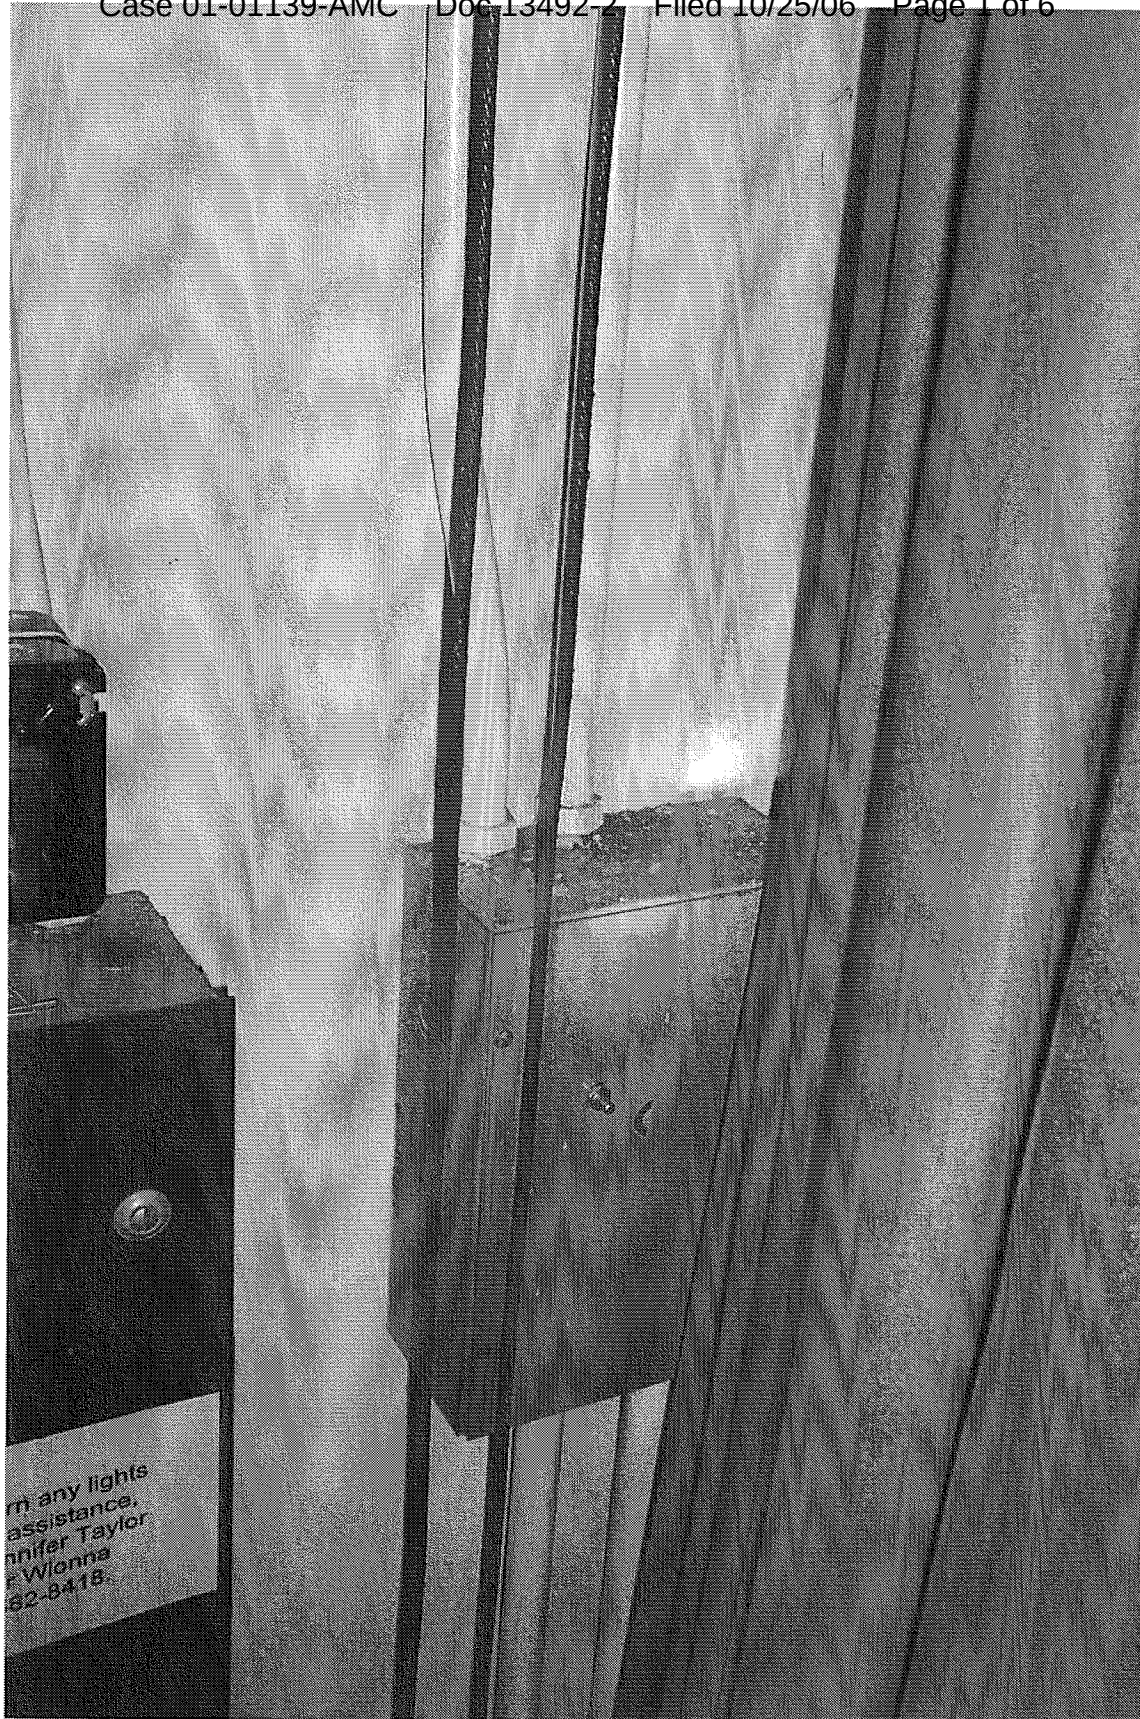
74. 1st floor auditorium - General view of stage curtains adjacent to breaker box (general location of dust sample #1)

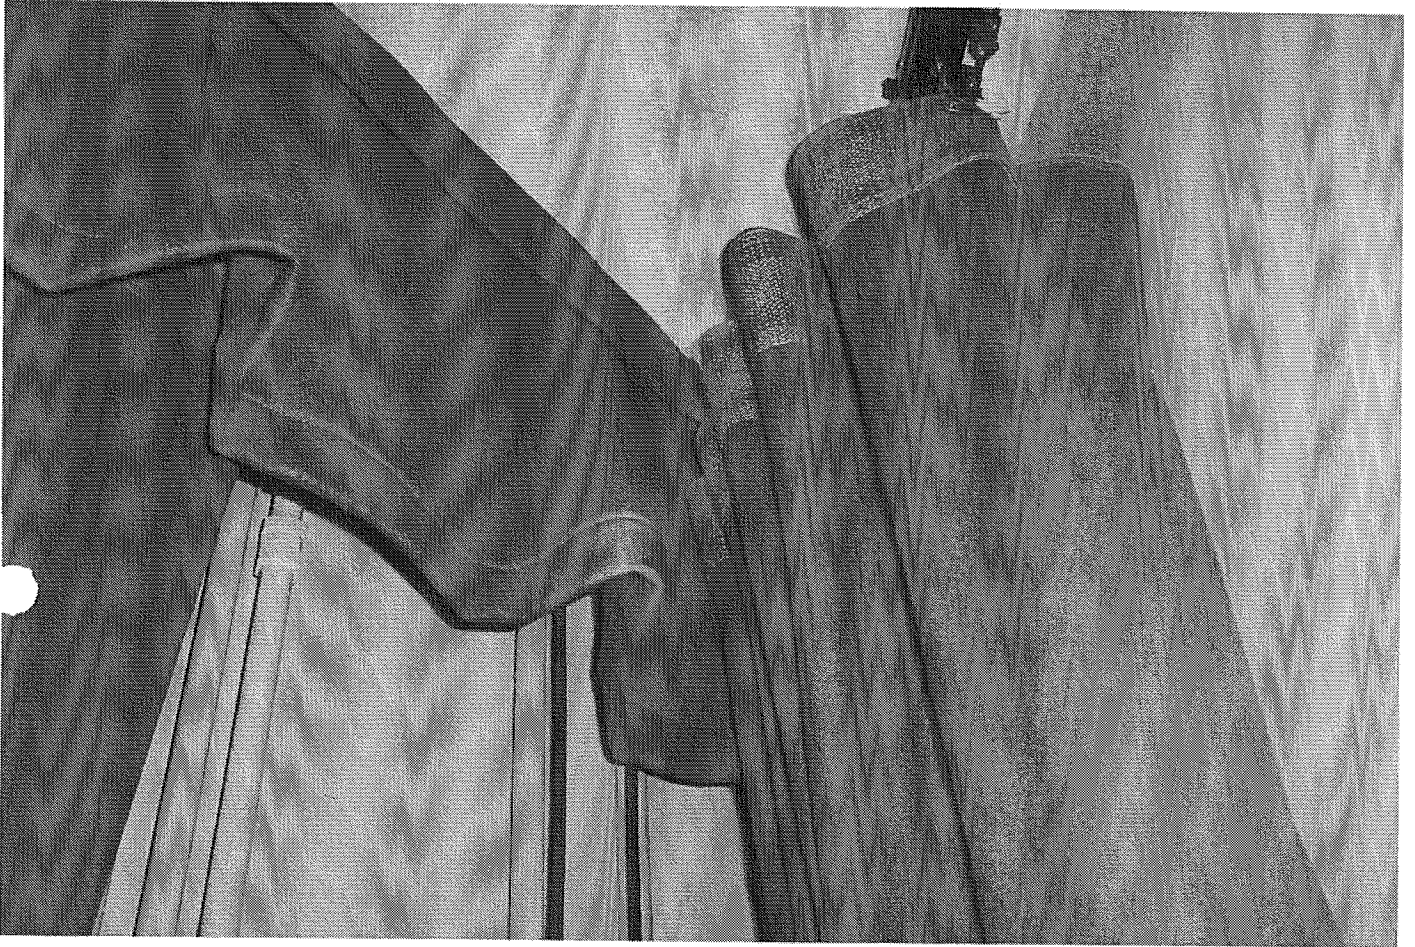
75. 1st floor auditorium - View of stage curtains above breaker box

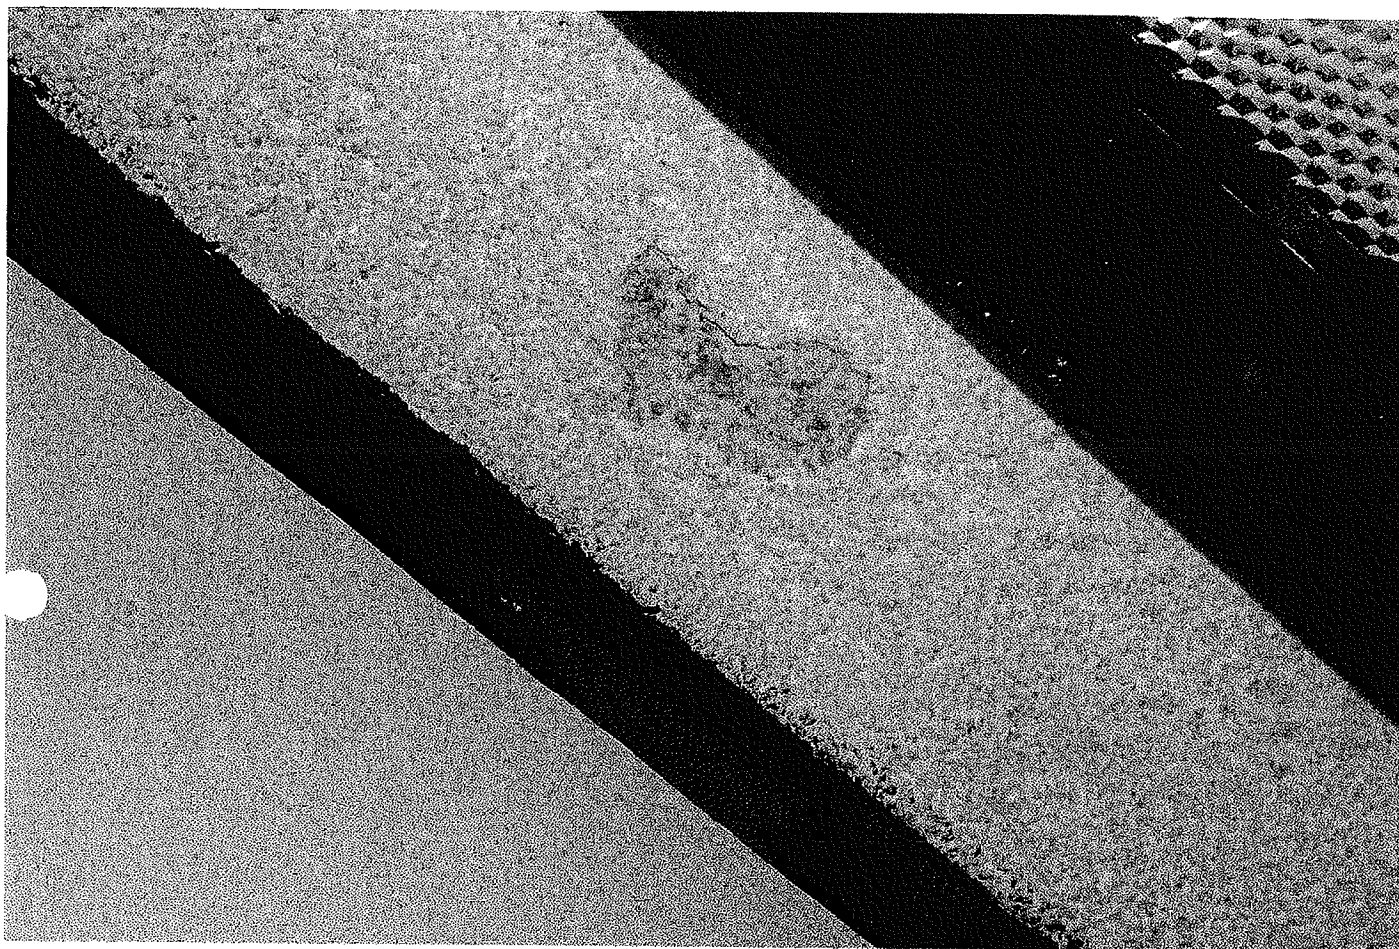
76. 1st floor auditorium - damaged acoustical plaster above stage

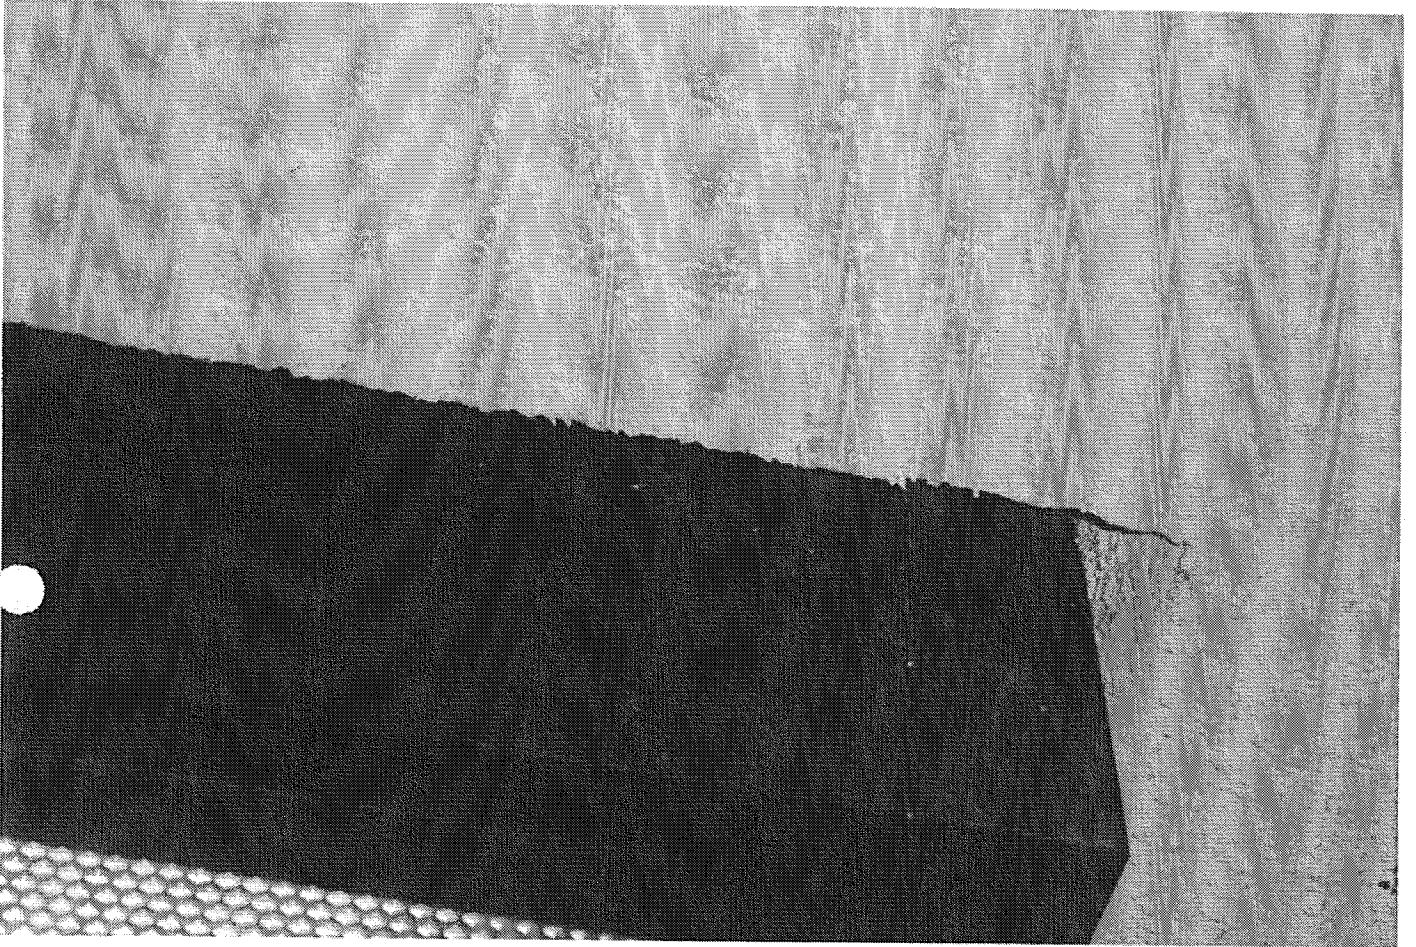
77. 4th floor west hallway - Eroded acoustical plaster next to square recessed light

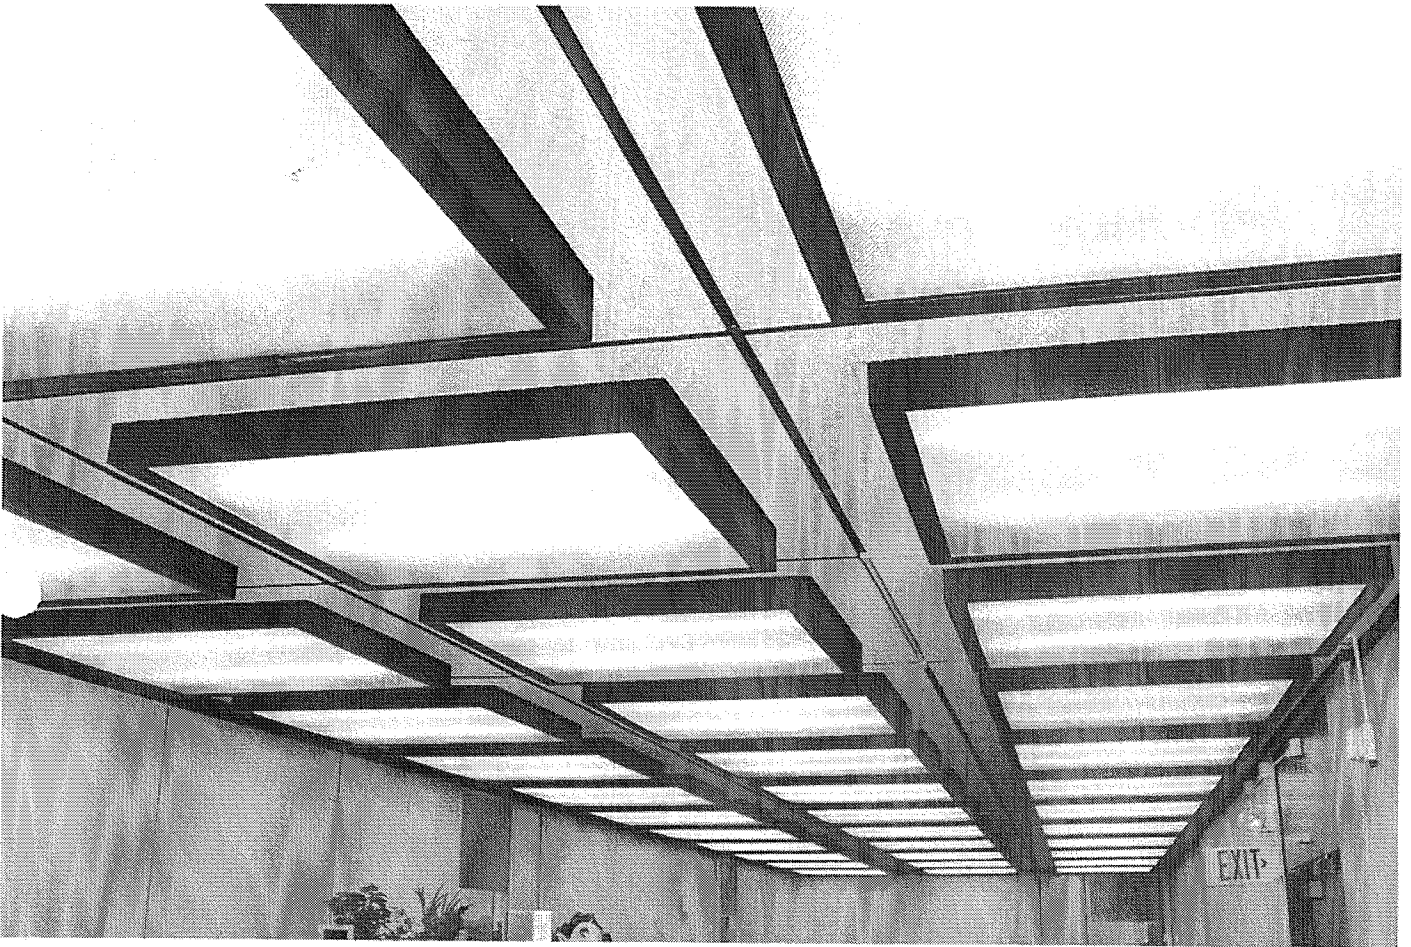
78. 4th floor elevator lobby - General view of acoustical plaster in lobby

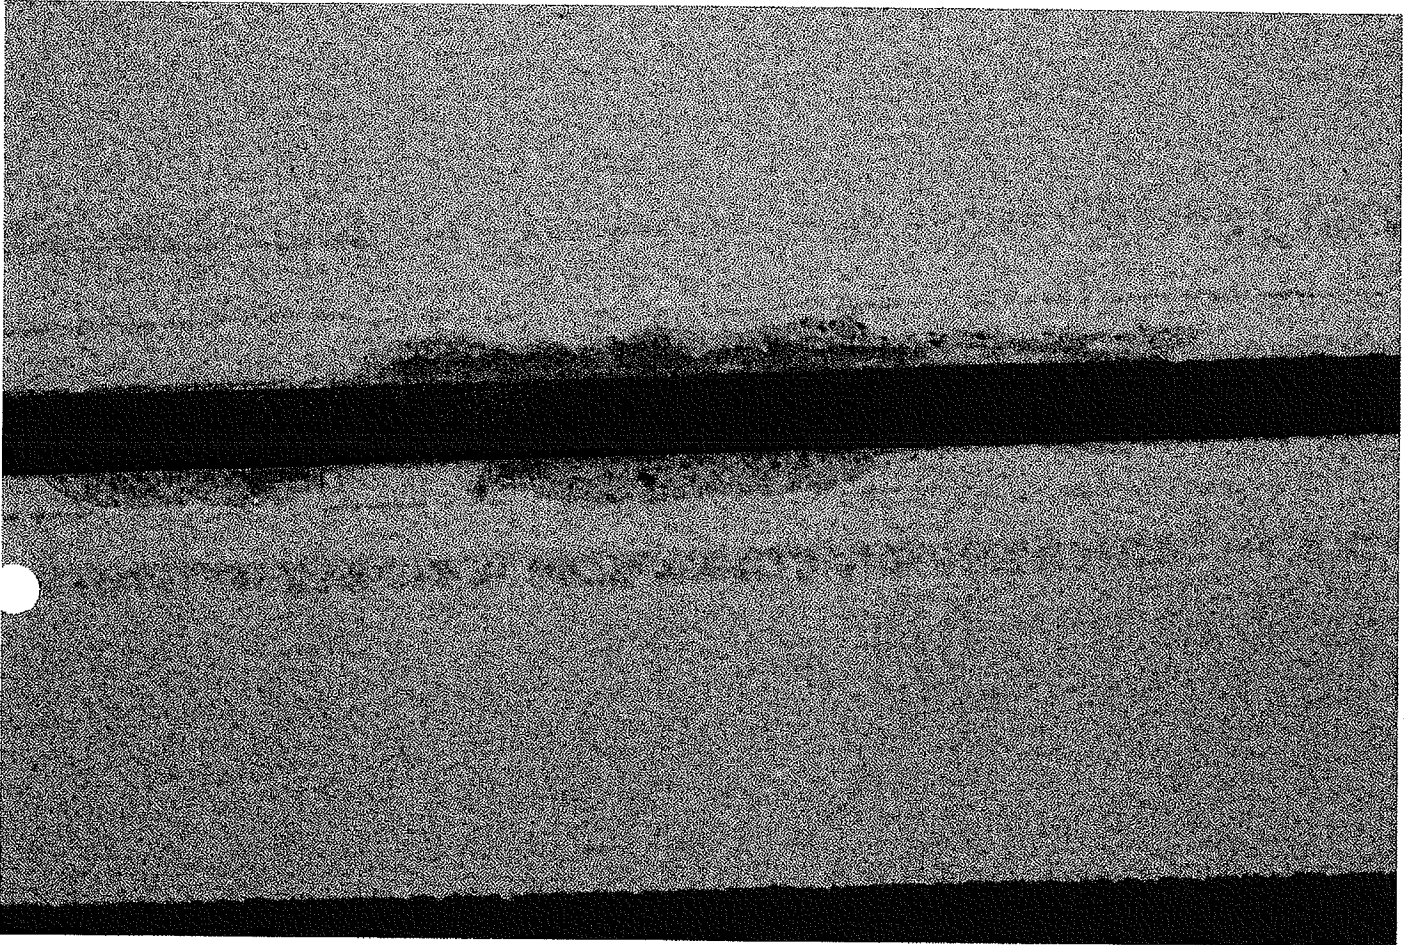
79. 4th floor, sw corner hallway - Close-up of damaged acoustical plaster on 4th floor south side
